## Large Woody Material Surveys on River Cam for North Cadbury and Yarlington Parish Council

March 2026

## Introduction

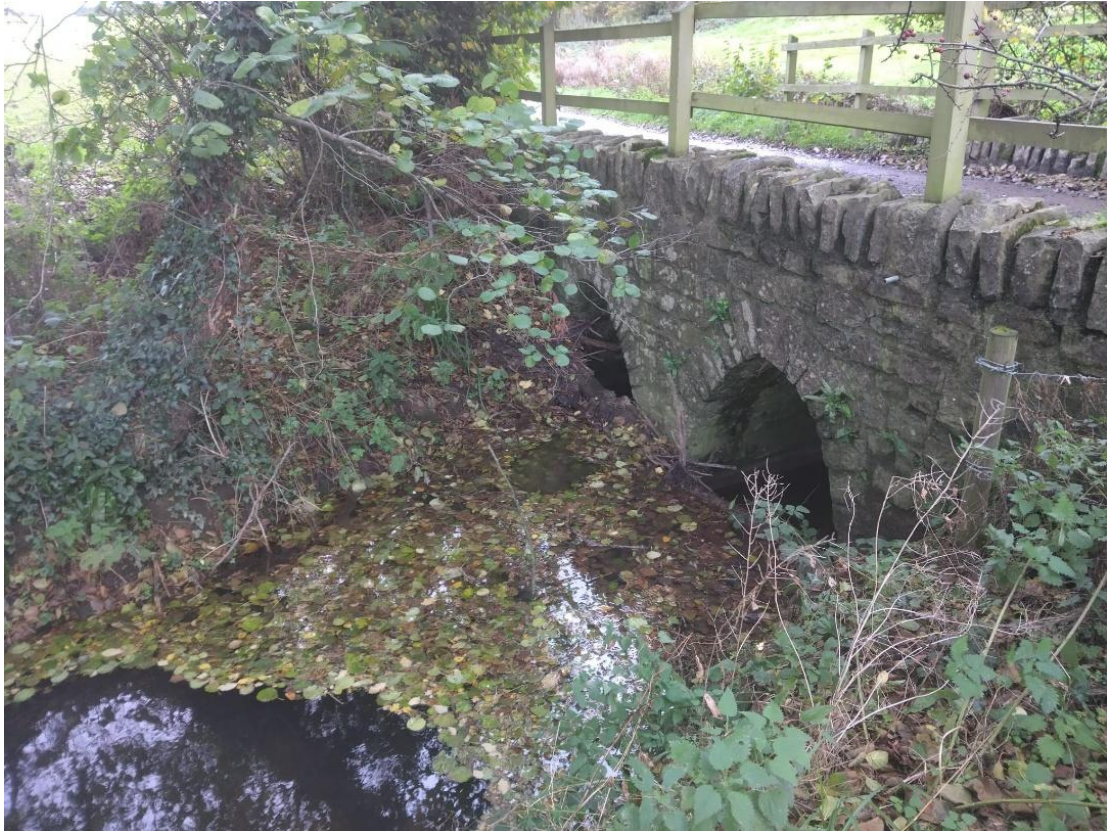
Debris accumulation at Sandbrook Lane Bridge

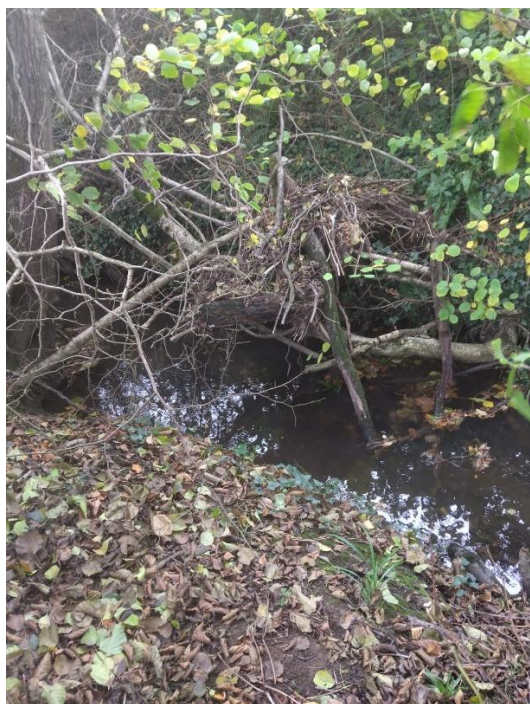
SL06	Major large woody material in-channel	Carefully manage to enhance logjam as this is currently protecting a small bridge. No removal required
SL07	Major large woody material in-channel	Carefully manage to enhance logjam as this is currently protecting a significant area of bank erosion and reducing impacts on the Sandbrook Lane Bridge downstream. No removal required
SL08	Woody material and other debris partially blocking one span of the Sandbrook Lane Bridge	Remove all woody material blocking the span
BH01	Major large woody material in-channel	LWM not in a vulnerable flooding location. Partially remove and/or realign to manage any risk appropriately
BH02	Major large woody material in-channel	LWM not in a vulnerable flooding location. Partially remove and/or realign to manage any risk appropriately
BH03	Accumulation of smaller woody material	Remove entirely from channel
BH04	Major large woody material in-channel	LWM not in a vulnerable flooding location. Partially remove and/or realign to manage any risk appropriately

SL06 Major Woody Material

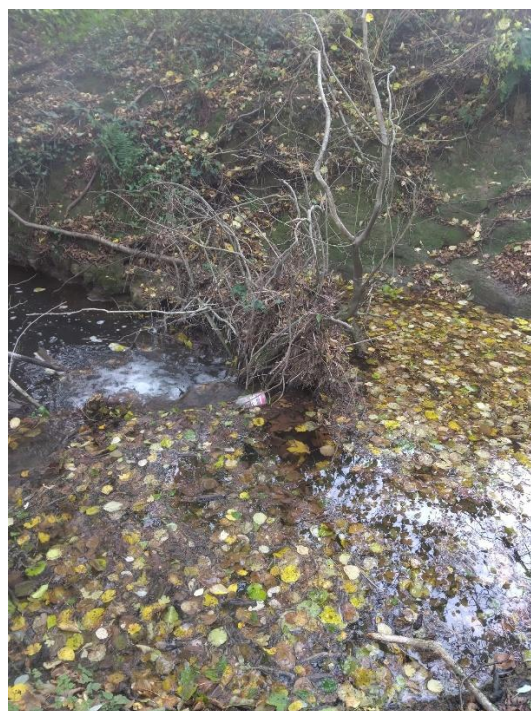
SL05 Minor Woody Material

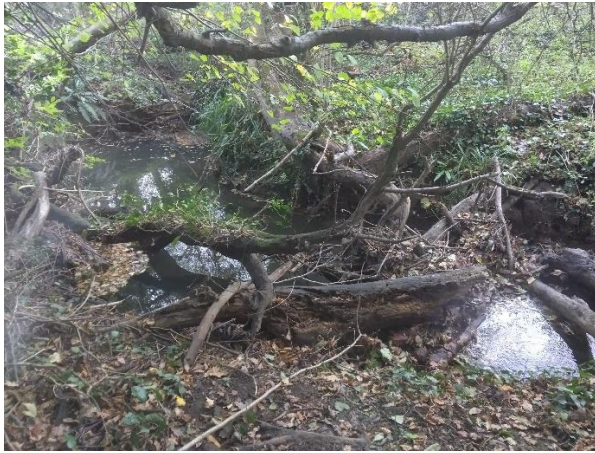
BH04 Major Woody Material

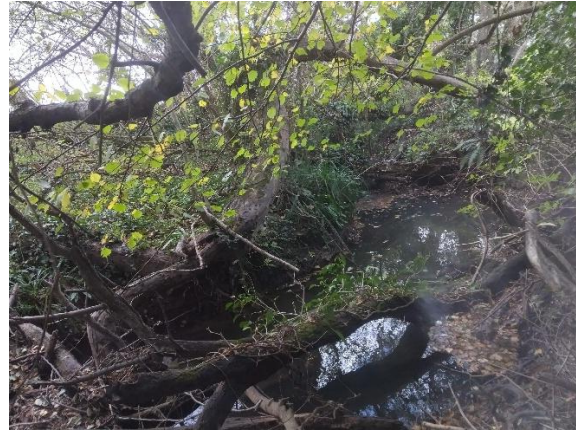
BH05	Major large woody material in-channel	LWM in good location to provide flood attenuation benefits. Targeted removal of problematic material if needed
BH06	Major large woody material in-channel	LWM in good location to provide flood attenuation benefits to bridge downstream. Enhance to improve stability and performance
BH07	Major large woody material in-channel	LWM in good location to provide flood attenuation benefits to bridge

BH05 Major Woody Material

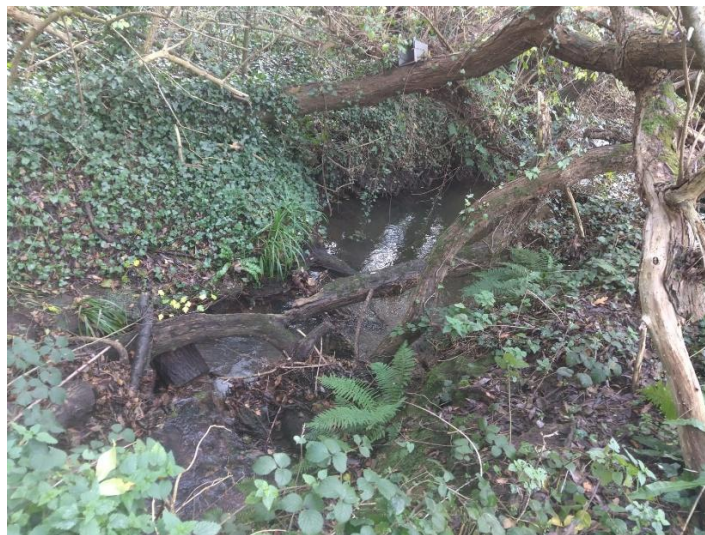
BH03 Minor Woody Material
