## Large Woody Material Surveys on River Cam for North Cadbury and Yarlington Parish Council

March 2026

## Introduction

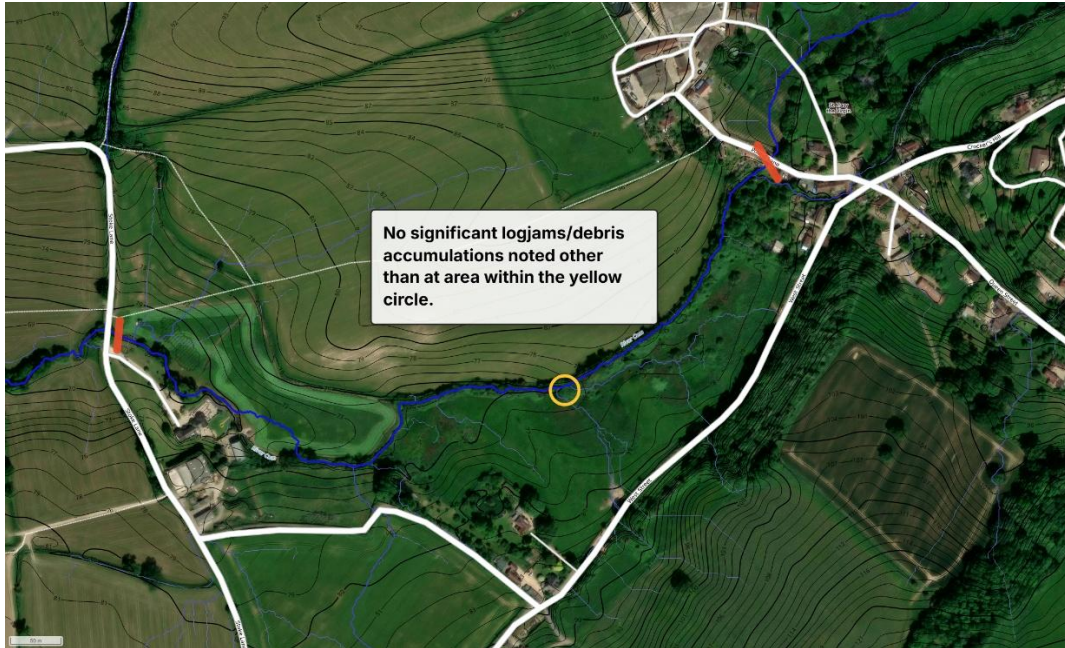
Map 4 Yarlinton Reach LWM locations

LWM Reference	LWM Feature	Actions
SL01	Significant bramble accumulation in-channel which could trap debris and cause backing up	Remove bramble within the channel perimeter
SL02	Accumulation of smaller woody material	Remove entirely from channel
SL03	Major large woody material in-channel	LWM not in a vulnerable flooding location. Partially remove and/or realign to manage risk appropriately
SL04	Accumulation of smaller woody material	Remove entirely from channel
SL05	Accumulation of smaller woody material	LWM not in a vulnerable flooding location. Partially remove and/or realign to manage risk appropriately

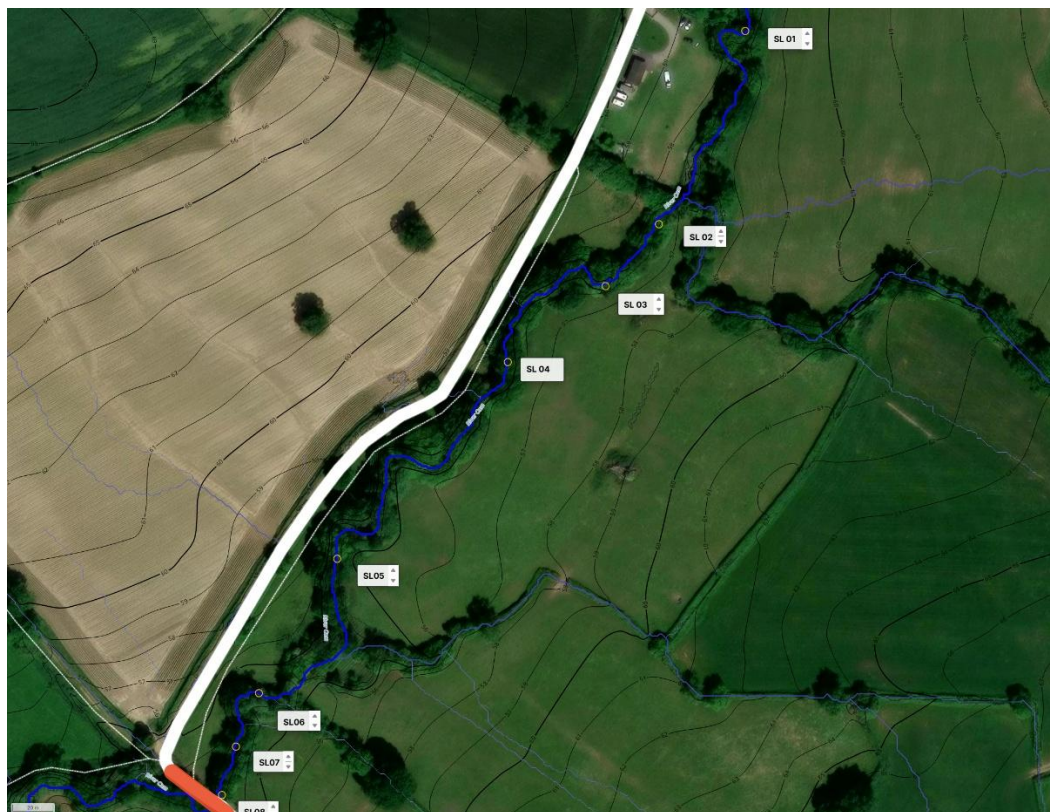
Map 5 Sandbrook Lane Reach LWM locations

SL06	Major large woody material in-channel	Carefully manage to enhance logjam as this is currently protecting a small bridge. No removal required
SL07	Major large woody material in-channel	Carefully manage to enhance logjam as this is currently protecting a significant area of bank erosion and reducing impacts on the Sandbrook Lane Bridge downstream. No removal required
SL08	Woody material and other debris partially blocking one span of the Sandbrook Lane Bridge	Remove all woody material blocking the span
BH01	Major large woody material in-channel	LWM not in a vulnerable flooding location. Partially remove and/or realign to manage any risk appropriately
BH02	Major large woody material in-channel	LWM not in a vulnerable flooding location. Partially remove and/or realign to manage any risk appropriately
BH03	Accumulation of smaller woody material	Remove entirely from channel
BH04	Major large woody material in-channel	LWM not in a vulnerable flooding location. Partially remove and/or realign to manage any risk appropriately

The Sandbrook Lane reach between Corkscrew Lane and SL01, had very few LWM accumulations requiring management. These were assessed as natural accumulations which are highly beneficial for stream ecology. It was noted that some limited bankside vegetation management, (mainly coppicing), would be helpful to reduce shading and reduce the potential for snagging on stems protruding into the channel perimeter. Vegetation in a state of decay and/or collapse would be sensible to target for this management to reduce woody inputs to the channel.
